# MAINTAINING ASSET INTEGRITY IN THE MINING AND QUARRYING INDUSTRY

Belzona Protective Coatings and Engineering Composites

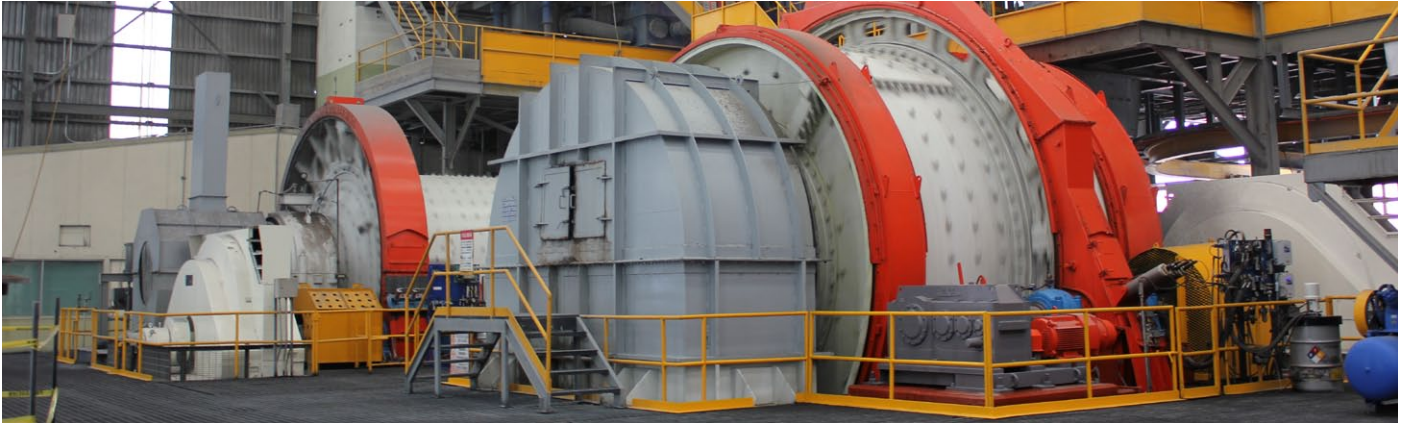
*When tested to ASTM standards, Belzona ceramic coatings for abrasion protection show minimum volume loss.*

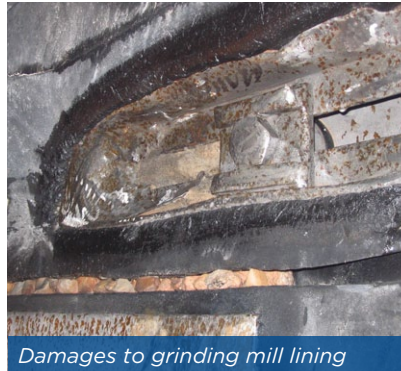
*Damages to grinding mill lining*

Severe wear occurs in different parts of grinding equipment, such as the liner, trunnion, trommel screen and external shell. Belzona has a wide array of products to withstand the friction and impact of grinding mechanisms. Belzona specifies the right solution for each problem area.

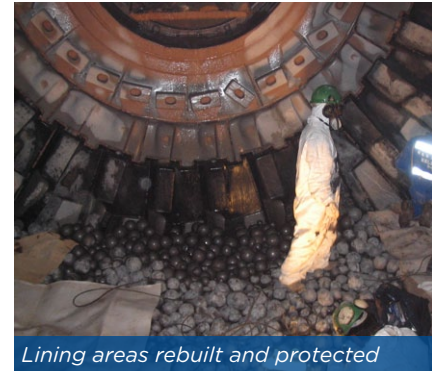
*Lining areas rebuilt and protected*

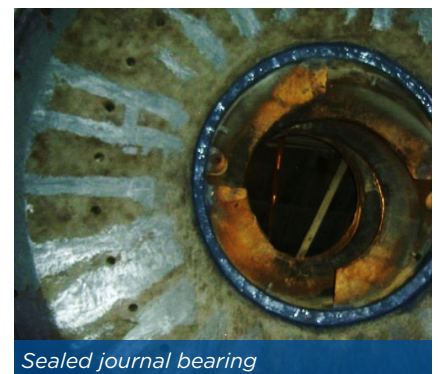
*Sealed journal bearing*

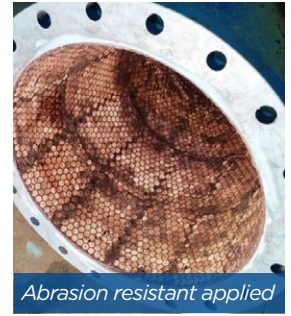
*Abrasion resistant applied*

Mining process materials can rapidly erode surfaces of bulk handling systems, such as hoppers, chutes, channels and feeders. The substrates are commonly constructed of erosion resistant alloys that are unsuitable for welding. Belzona abrasion resistant lining systems consisting of alumina tiles and epoxy polymers have been successfully utilized to withstand the effects of wear, thus avoiding welding procedures and minimizing downtime.

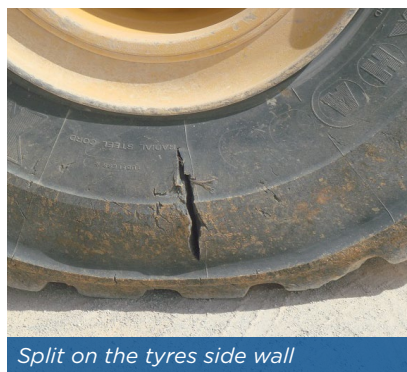
*Split on the tyres side wall*

The tyres of off-road vehicles typically operate at low pressure, causing a great deal of compressive stress to the side wall of the tyre in contact with the ground. The stress enlarges splits and holes due to the stretching of the rubber. Belzona Elastomers quickly repair and prevent further deterioration, for that reason extending the life cycle of the tyres.

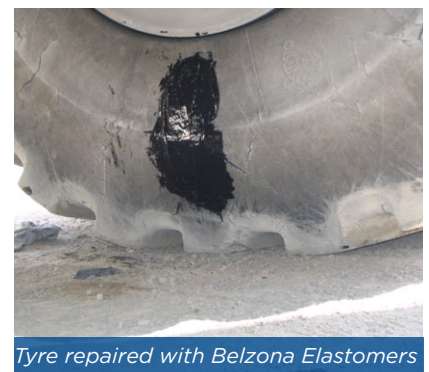
*Tyre repaired with Belzona Elastomers*

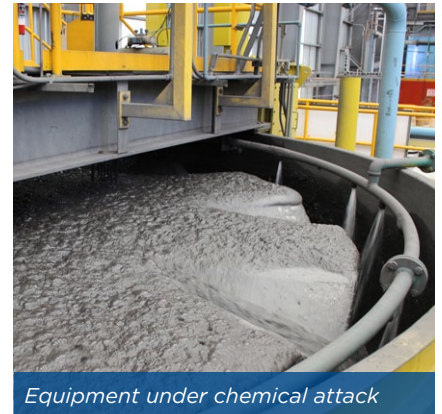
*Equipment under chemical attack*

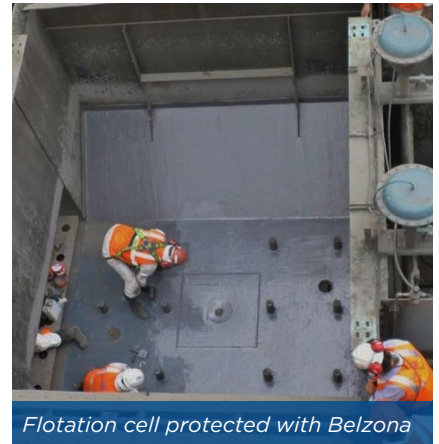
*Flotation cell protected with Belzona*

Damage in flotation cells is caused by the constant abrasion of the ore hitting the tanks walls. Galvanic corrosion occurs at the steel surfaces once abrasion starts. The sediment of the ore in flotation cells is very abrasive, thus affecting the tank floor. Belzona repair composites are used to fill the voids in the metal walls and Belzona erosion-corrosion resistant coatings are used to provide a seamless lining.

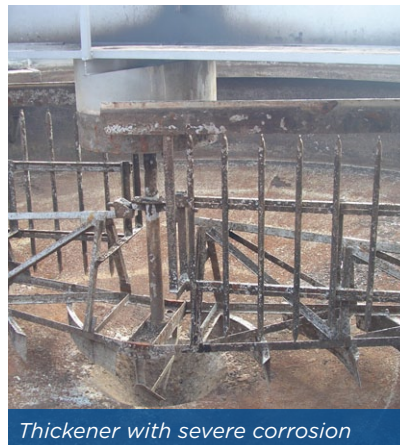
*Thickener with severe corrosion*

Solid components in thickeners begin to compress as they settle on the bottom of the tank. Chemical flocculants and coagulants are used to increase the performance of the process of thickeners. The combination of these chemicals plus the solids in the slurry are very aggressive to the thickener tank and its rake mechanism. Belzona immersion barrier coatings protect against chemical attack and prolong the working life of the equipment.

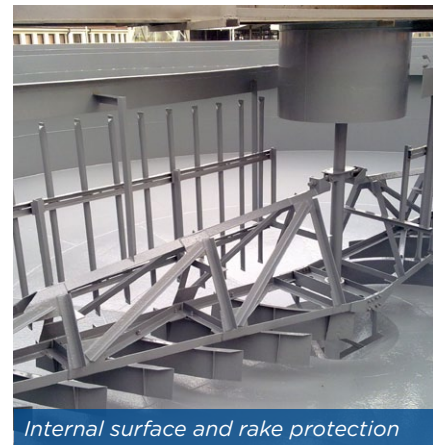
*Internal surface and rake protection*

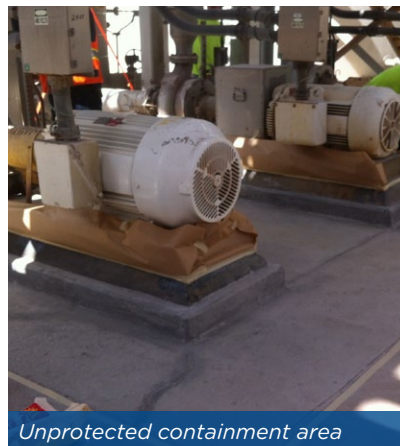
*Unprotected containment area*

Chemical spillage is inevitable and will corrode and deteriorate containment areas, such as bunds and sumps, that could lead to potentially catastrophic consequences and environmental pollution. The versatile application of Belzona's chemical linings, by brush or spray, can reduce both application time and downtime.

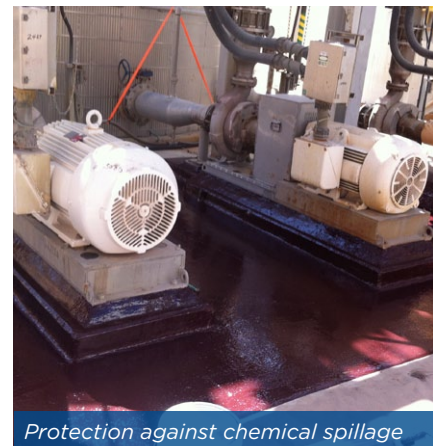
*Protection against chemical spillage*

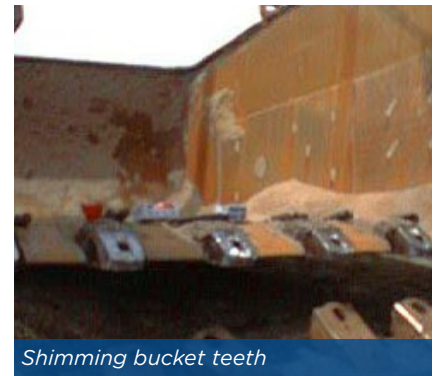
*Shimming bucket teeth*

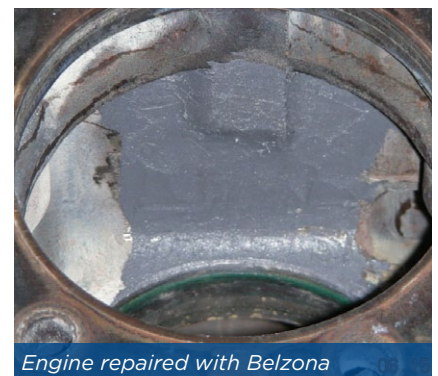
*Engine repaired with Belzona*

Water circulating through the engine block freezes and expands, or escapes from the system at the core plugs, causing the blocks to crack. The conventional repair by welding can cause deformation to the substrate or leave the welded area more brittle and susceptible to further cracking. Belzona metallic polymers safely seal cracked blocks with simple procedures while offering an inexpensive solution by avoiding costly engine substitutes.

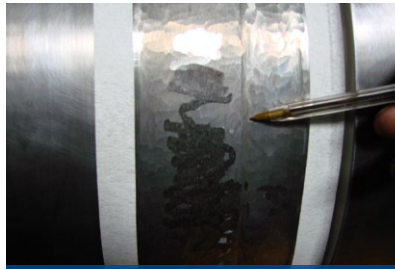
*Worn out shaft*

Shafts become worn and damaged due to vibration, rubbing, abrasive contaminants and corrosion. Where it is impractical to strip a shaft, Belzona metallic polymers can repair in-situ without the risks that result from welding procedures.

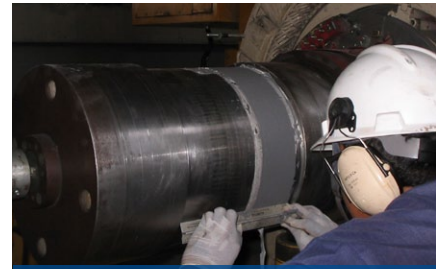
*Shaft rebuilding in progress*

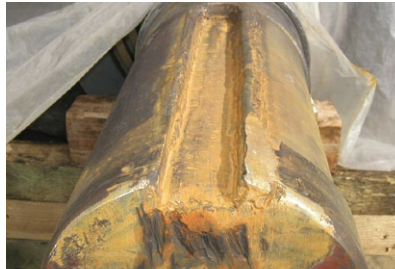
*Enlarged keyway*

Keyways become worn and oversized due to constant pressure from starting and stopping, causing vibration, misalignment, and stress on couplings. Belzona epoxy composite materials are designed to repair and prevent these common failures to mechanical power transmission equipment. Using a new key as a former, a perfect zero-tolerance fit is created. This simple repair saves time and money, while quickly returning the equipment to operation.

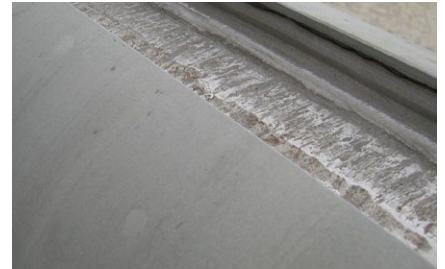
*Keyway repaired*

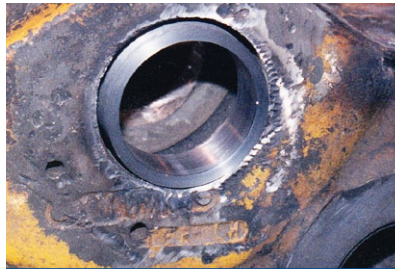
*Oversized housing*

Abrasive wear to bearing housings is a result of seizures and/or heavy loading. To provide in-situ and cost-effective repair solutions, Belzona paste grade metallic polymers are recommended to rebuild the oversized housings, allowing the machinery to rapidly return to service with minimum downtime.

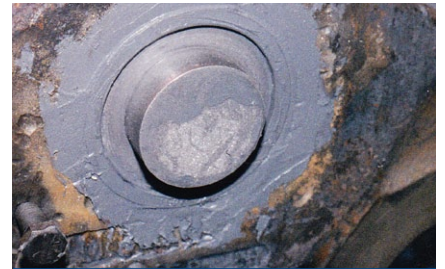
*Housing repaired*

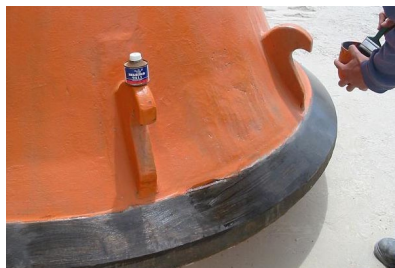
*Surface preparation in progress*

Movement and vibration causes wear and tear to crusher components, such as fasteners of the bowl liner. Belzona solves the problem in-situ, avoiding the need to stock spare parts. Our solutions deliver a significantly longer life to equipment and reduce expenses by eliminating the need for new parts.

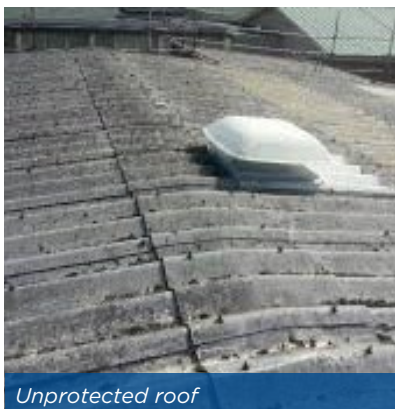
*Unprotected roof*

Belzona liquid applied polymeric membrane systems have been offering unrivaled water and weatherproofing for all types of roofing substrates as well as insulation since 1966. Additionally, its flexibility allows for complex architectural designs, seamless protection and movements in sympathy with the substrate, allowing for expansion and contraction. Emergency solutions are also available, allowing for the application to be carried out directly onto wet surfaces.

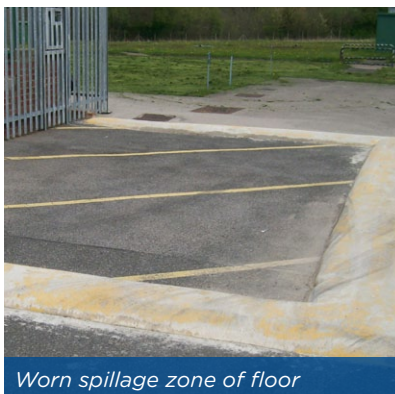
*Worn spillage zone of floor*

Damaged and worn concrete and stone floors can be quickly repaired and protected using Belzona epoxy composites and coatings. Our solutions provide outstanding impact and abrasion resistance and also offer excellent chemical resistance against a wide range of chemicals.

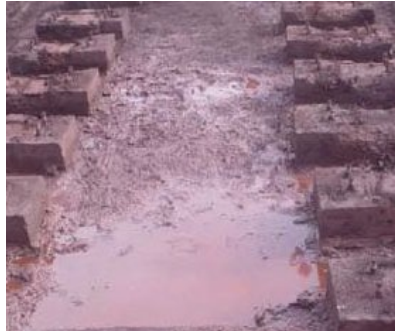
*Damaged bases of railroad tracks*

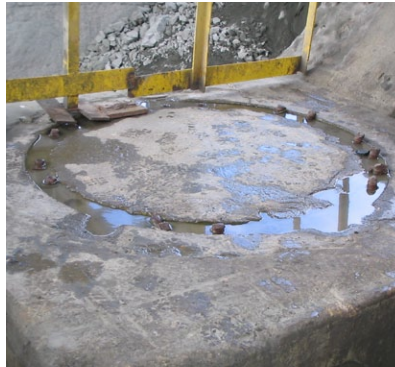
*Damaged concrete base*

Bases, plinths and supports suffer from damage caused by impact, vibration or chemical attack. The machinery and equipment of the above mentioned and their contents are extremely valuable assets, thus its protection is essential.

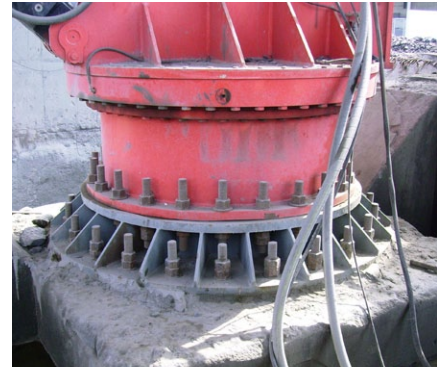
*Completed application*

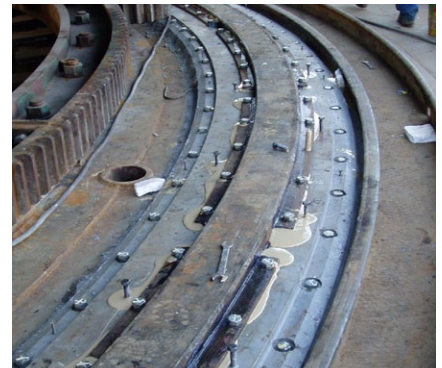
*Completed injection*

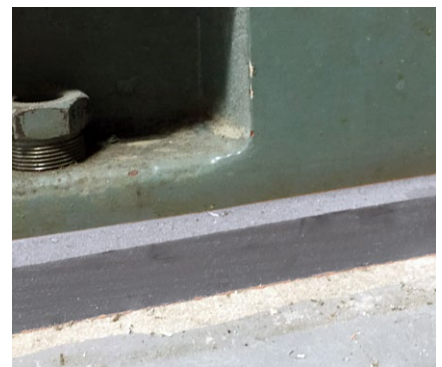
*Precise alignment of the equipment*

Belzona industrial chocking compound has been designed for the precise installation of engines, mills and other equipment. Belzona provides precise alignment per its non-shrinking properties whilst its high impact and compressive strength provides high load bearing capabilities.
